Manhole Inspection Summary

Manhole # S69Q__012MH

Location Address: **1412 Dunalk Ave.**

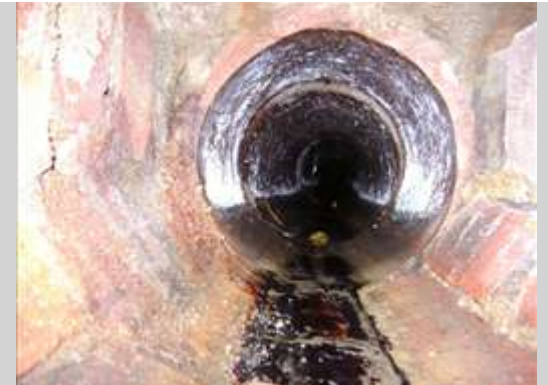
6 O'Clock Inflow

8 in. Circular Gravity Sewer

Pipe In @ 6 O'Clock

Pipe Height: **8.4** (in.) Rod and Bar (Angled)

Pipe Material: **Clay** ☐ Pipe Lined

Infiltration: **None** Pipe Seal Cond: **Sound**
